Device **TC29x**
Marking/Step **ES-BB, BB**
Package **see Data Sheet**

No. 029/19

This Errata Sheet describes the deviations from the current user documentation.

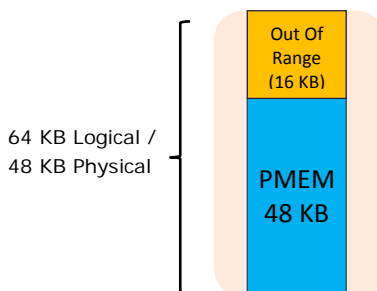
Figure 1 Example for Non-Power of Two PMEM

CPU_TC.126 Unexpected Address Error Alarms caused by Speculative Access to Out-of-range PMEM and DMEM Areas

In TC29x, the following CPUs and memories are affected:

- PMEM side issue: CPU0 PMEM
- DMEM side issue: CPU1 and CPU2 DMEM.

Note: The issue only affects non-power of two PMEM and DMEM memories of a TC1.6P CPU as described above. Other CPU cores and memory configurations are not affected.

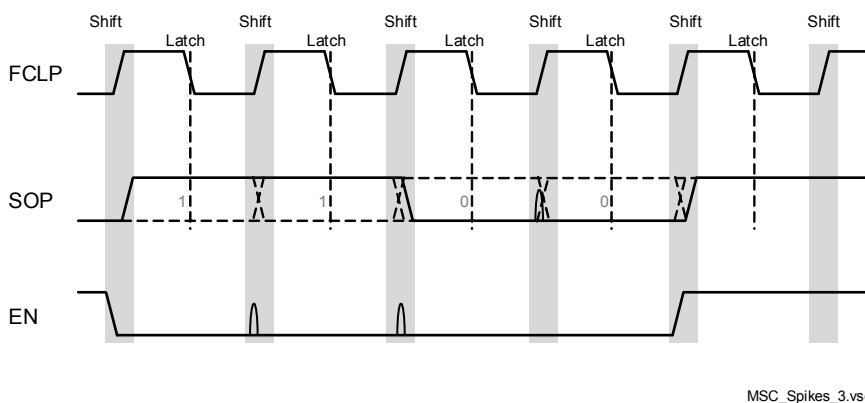
Figure 5 Theoretical Example for MSC Spike Scenario

The ABRA block of the MSC generates spikes in the serial output data (SO) and enable (EN0 to EN3) signals, that under some worst case conditions might become visible at the output of the corresponding pins.

The spikes would appear as shown in **Figure 5**, within the normal signal transition timing intervals, as defined with the data sheet timings t44 (SOPx output delay) and t45 (ENx output delay). The spikes would not cause violation of the timings.

Each MSC module instance (MSC0, MSC1 ...) of each device (TC26x, TC27x, TC29x) shows specific behavior regarding the width of the spikes, depending on the on-chip synthesis of the particular instance.

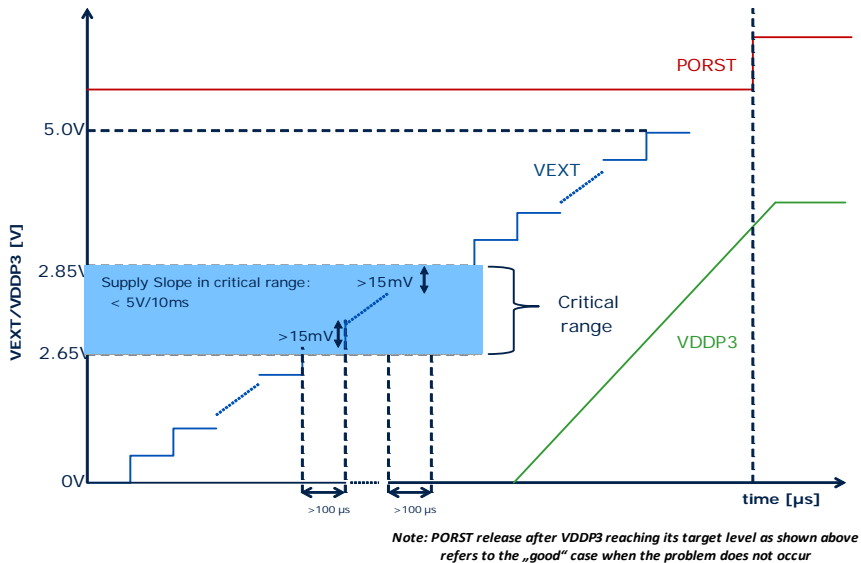
Figure 6 EVR Supply Voltage VEXT Ramp-up - Critical Range
Workaround

- The fail behavior is observed only if the internal EVR33 regulator is used.
- The fail behavior is not observed together with TLF35584 regulator (owing to fast ramp-up slopes).

Ensure that the minimum slope for the EVR Supply Voltage (VEXT) is faster than 5V/10ms (see also Data Sheet, symbol dV_{in}/dT).

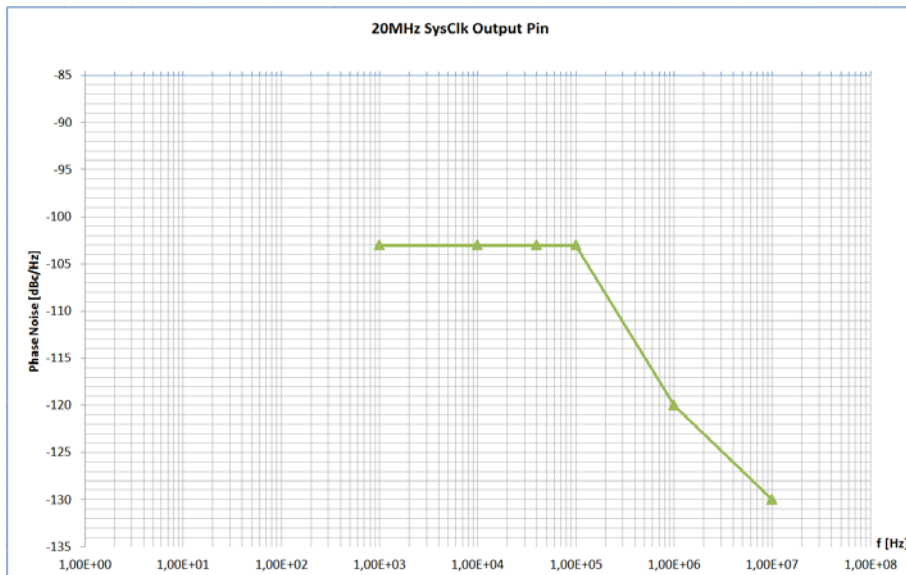
Figure 8 Phase Noise Density on SysClk Output Pin

The diagram below shows the phase noise density on the SysClk pin when no application pattern but only the HSSL/HSCT subsystem is running:

1) integration range from 10 kHz to 10 MHz

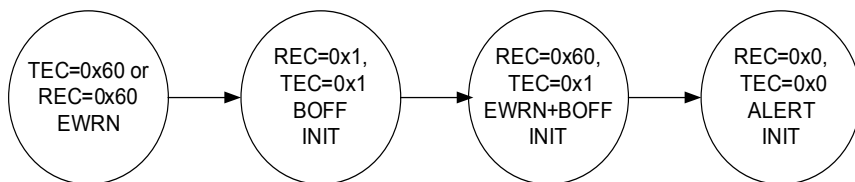
Figure 10 Alert Interrupt Behavior in case of Bus-Off

MultiCAN_AI.H007 Alert Interrupt Behavior in case of Bus-Off

When the threshold for error warning (EWRN) is reached (default value of Error Warning Level EWRN = 0x60), then the EWRN interrupt is issued. The bus-off (BOFF) status is reached if TEC > 255 according to CAN specification, changing the MultiCAN module with REC and TEC to the same value 0x1, setting the INIT bit to 1_B, and issuing the BOFF interrupt. The bus-off recovery phase starts automatically. Every time an idle time is seen, REC is incremented. If REC = 0x60, a combined status EWRN+BOFF is reached. The corresponding interrupt can also be seen as a pre-warning interrupt, that the bus-off recovery phase will be finished soon. When the bus-off recovery phase has finished (128 times idle time have been seen on the bus), EWRN and BOFF are cleared, the ALERT interrupt bit is set and the INIT bit is still set.

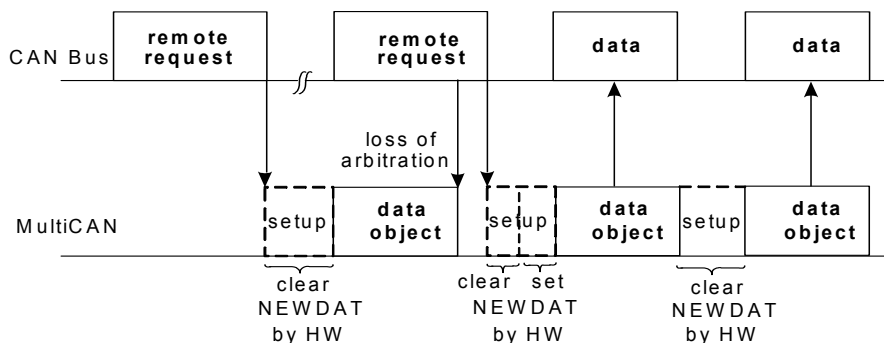
Figure 11 Loss of Arbitration

When the appropriate message object (data frame) triggered by the first remote frame wins the arbitration, it will be sent out and `NEWDAT` is not reset. This leads to an additional data frame, that will be sent by this message object (clearing `NEWDAT`).

There will, however, not be more data frames than there are corresponding remote requests.

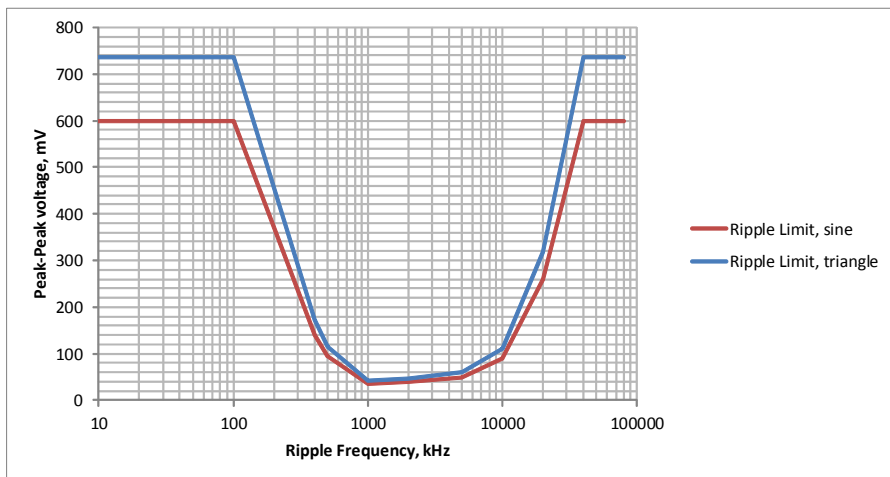
Figure 12 Ripple Voltage vs. Frequency Characteristic

The internal back-up clock is sensitive to specific power supply voltage disturbance/ripple caused by a voltage ripple intrinsic to DC-DC converters. Specific conditions such as insufficient filtering of the ripple may lead to improper behavior of the start-up scheme of the back-up clock, and thus stuck-at state during the start-up of the microcontroller until this condition is removed.

The acceptable voltage vs. frequency characteristic is portrayed below on the chart:

The diagram reflects acceptable ripple level during the cold start of the microcontroller at the VDDP3 supply of the PMS subsystem. For devices in QFP-144, QFP-100 and QFP-80 packages the ripple is reflected for pin 69, pin 47, and pin 37, respectively.

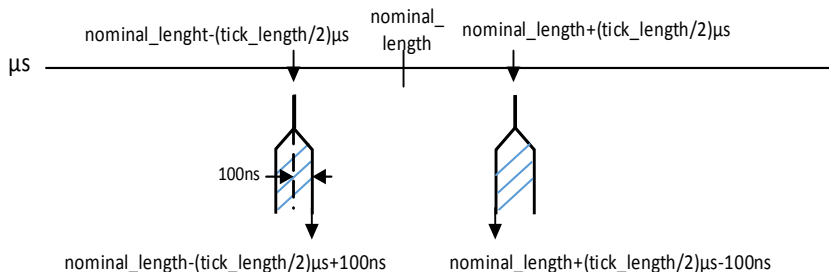
Figure 13 SENT Standard Tolerance

The length of a nibble in the SENT protocol determines the value of this nibble. For each value this length can vary, but it has to be at least inside a given range. This range is given by the SENT standard.

- The lower border is $\text{nominal_value} - (\text{tick_length}/2) \mu\text{s} + 100 \text{ ns}$
- The upper border is $\text{nominal_value} + (\text{tick_length}/2) \mu\text{s} - 100 \text{ ns}$.

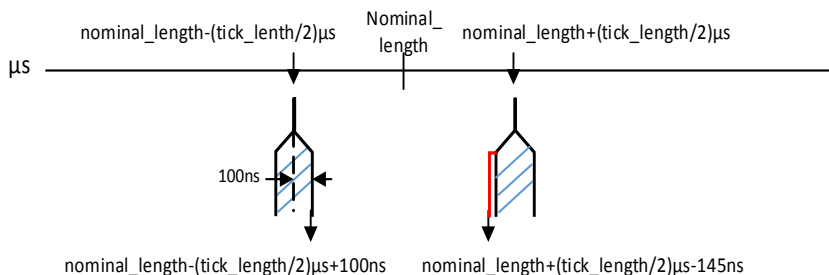
Figure 14 SENT Tolerance of this Design Step

In this design step the range is delimited as follows:

- The lower border is $\text{nominal_value} - (\text{tick_length}/2) \mu\text{s} + 100 \text{ ns}$
- The upper border is $\text{nominal_value} + (\text{tick_length}/2) \mu\text{s} - 145 \text{ ns}$.

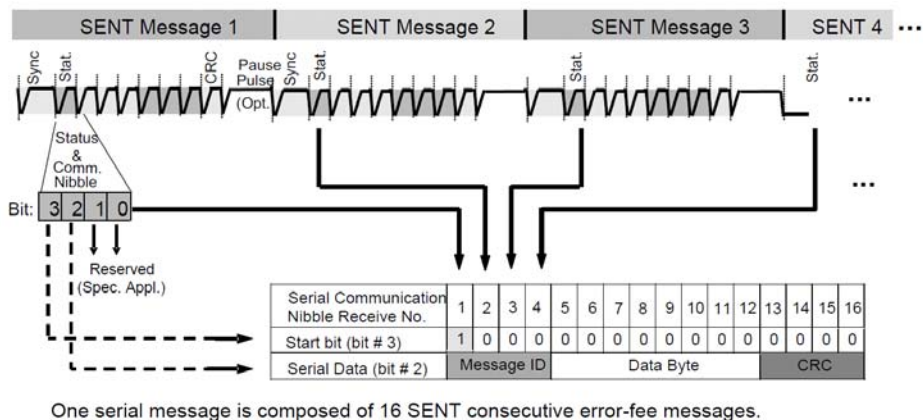
Figure 15 Short Serial Message, Serial Data Encoding over 16 messages

Figure 15 shows a corrected version of this figure.
