# Device Errata

## mPCIe Adapter Board

NimbeLink // Products

Published // February 18, 2016

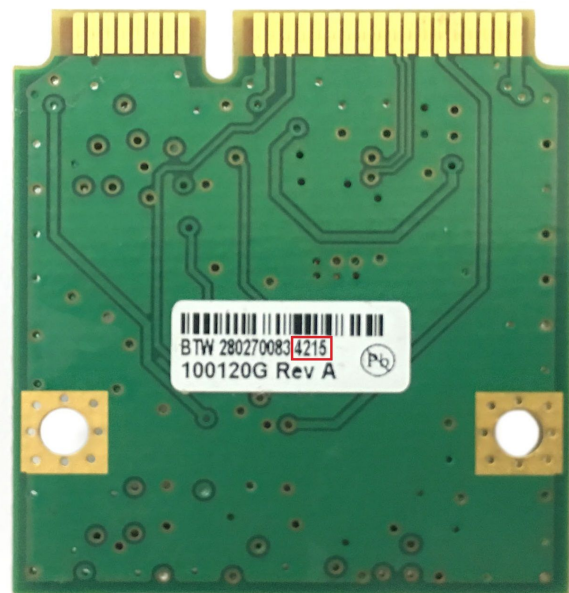
The manufacturer date code is located on the back side of the mPCIe Adapter Board on a white sticker. The manufacturer revision number is at the end of the first

line of printed text on the sticker and is of the form of 'WWYY' where WW is the manufacturing week and YY is the manufacturing year. This Errata affects all mPCIe boards with a date code before 0116.

The Errata can be repaired on affected product by replacing resistor R5 with a size 0603 zero (0) ohm resistor. Replacing R5 will not invalidate the product warranty, however, poor workmanship can damage the board and invalidate the warranty.
