## USB72x6/USB7252 Silicon Errata and Data Sheet Clarification

This document describes known silicon errata for the following USB72x6/USB7252 devices:

- USB7206
- USB7216
- USB7252

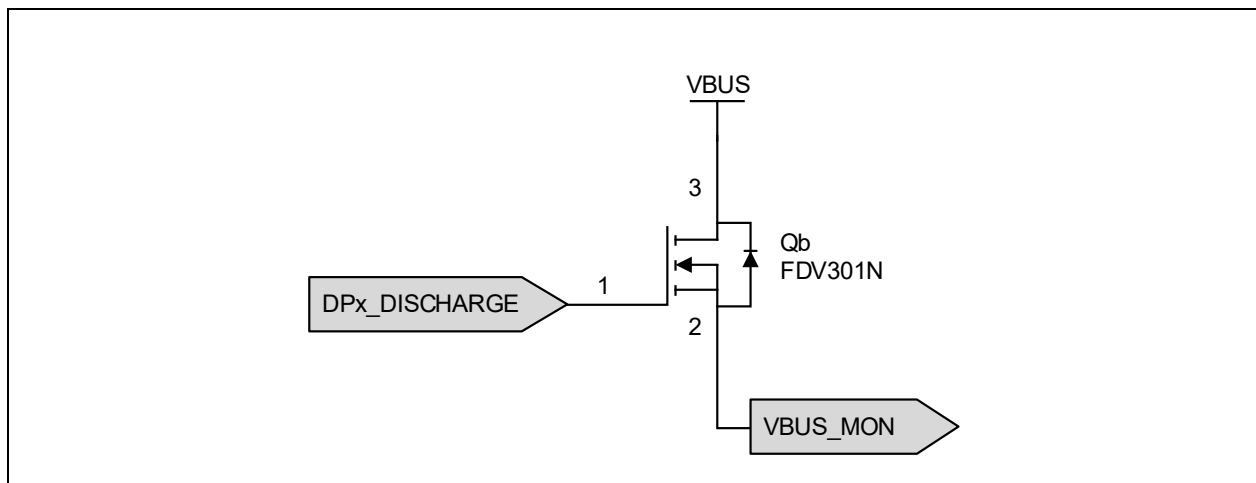
**FIGURE 2: TYPE-C DISCHARGE WORKAROUND FOR MODULE 3**

One requirement for USB-IF compliance certification of a system with an exposed Type-C port is the *Port Power On/Off* test. This test is part of the HUBCV suite of *Command Verification* tests for USB 2 devices. As part of this test, the hub must discharge VBUS, and then energize VBUS in response to CLEAR\_FEATURE and SET\_FEATURE commands from the test host.

Frequently, these ports will be implemented with electrolytic VBUS load capacitors, which retain a small residual charge that is released slowly compared to the timing of the discharge. In such cases, as energy is released from the capacitor the voltage can drift upward slightly after the discharge, which can cross the VBUS\_DET threshold for detecting VBUS high. In the sequence of the Port Power On/Off test, this can inhibit subsequent turning on of VBUS in response to commands from the test host and the test fails.

Type C ports that have a large electrolytic capacitor may require this workaround to pass the HUBCV Port Power On/Off test.

In reference designs for USB7216 and USB7252 devices, an N-channel MOSFET with a  $V_{GS}$  less than 1.0V is connected between VBUS and VBUS\_MON, with gate control from the DISCHARGE signal. This additional component creates an additional current path as the discharge is monitored by VBUS\_MON, which biases VBUS\_MON higher. This results in discharge to a lower voltage than what is otherwise achieved, and compensates for any residual energy that the capacitor releases after the discharge. At times other than the discharge, the MOSFET is turned off and does not influence VBUS.

No components of the reference design need to be removed; only the MOSFET is added.
