Device **TC23x**
Marking/Step **ES-AC, AC**
Package **see Data Sheet**

10210AERRA

This Errata Sheet describes the deviations from the current user documentation.

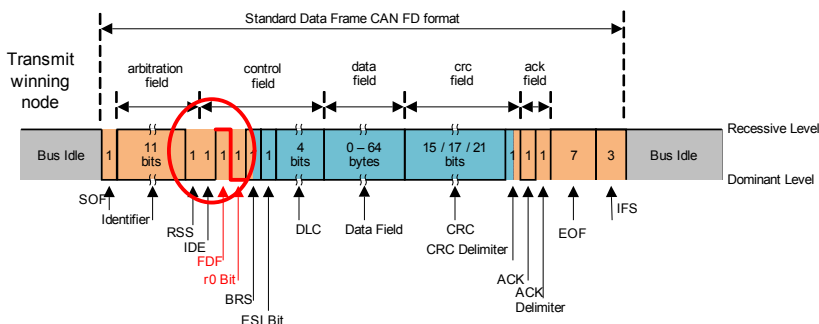
Figure 4 Transmitter - winning CAN FD node

The device is producing more error frames within a network than a device with a hardsync at the FDF bit.

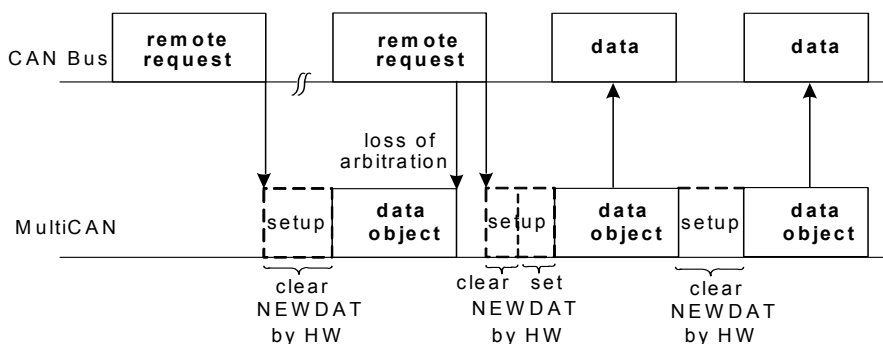
Figure 9 Loss of Arbitration

When the appropriate message object (data frame) triggered by the first remote frame wins the arbitration, it will be sent out and NEWDAT is not reset. This leads to an additional data frame, that will be sent by this message object (clearing NEWDAT).

There will, however, not be more data frames than there are corresponding remote requests.

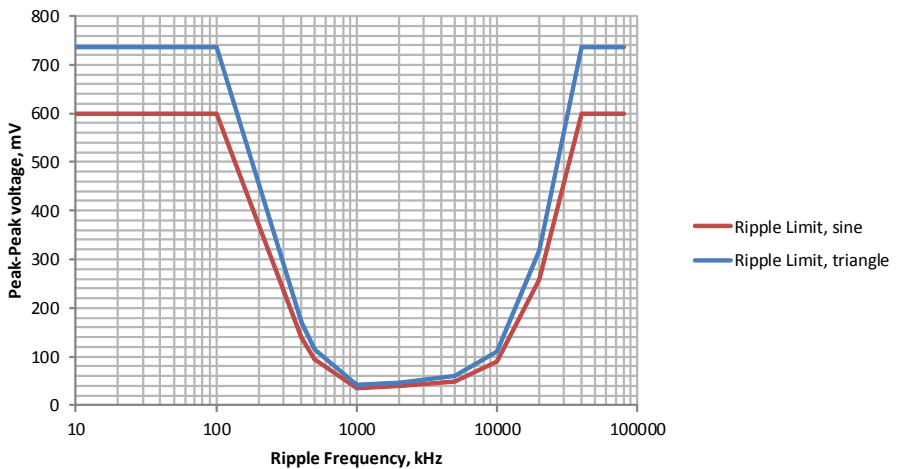
Figure 12 Ripple Voltage vs. Frequency Characteristic

The internal back-up clock is sensitive to specific power supply voltage disturbance/ripple caused by a voltage ripple intrinsic to DC-DC converters. Specific conditions such as insufficient filtering of the ripple may lead to improper behavior of the start-up scheme of the back-up clock, and thus stuck-at state during the start-up of the microcontroller until this condition is removed.

The diagram reflects acceptable ripple level during the cold start of the microcontroller at the respective VDDP3/VEXT/VEVRSB supply of the PMS subsystem, depending on the device and package type, as shown in the following table.
