Applicability

It gives a summary and a description of the device errata, with respect to the device datasheet and reference manual RM0351.

Table 1. Device summary

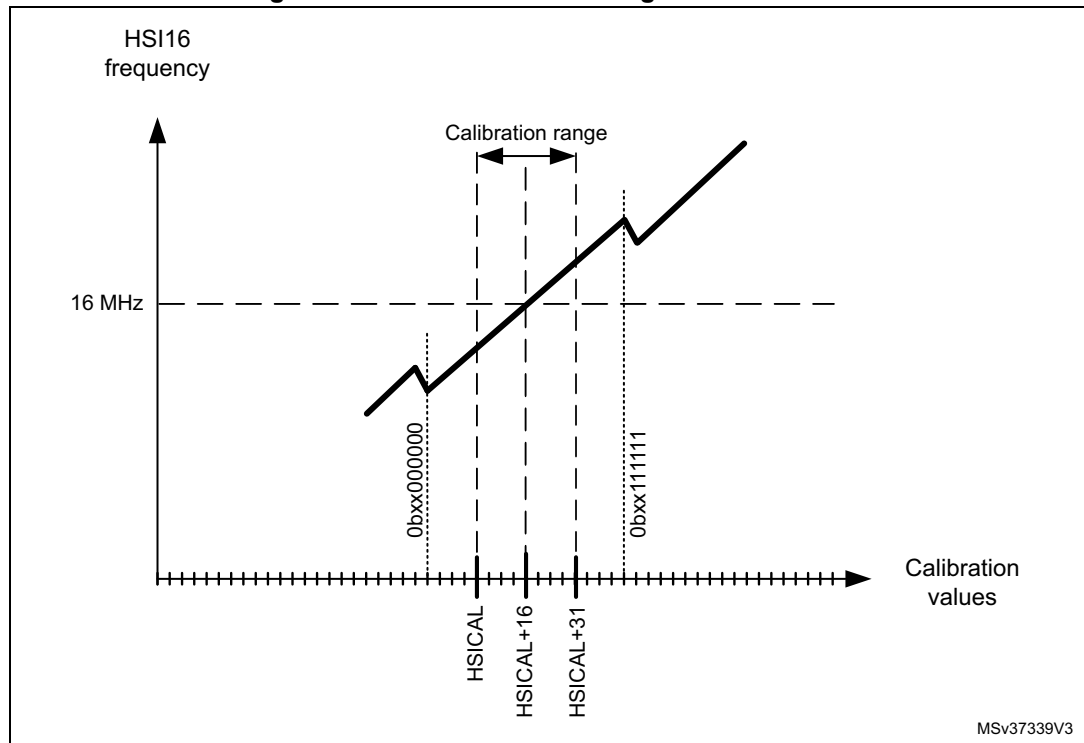
Figure 1. HSI oscillator trimming characteristics

Consequently, the user trim correction must not jump over the codes multiple of 64, which can limit the user correction either in positive or in negative direction.

None.

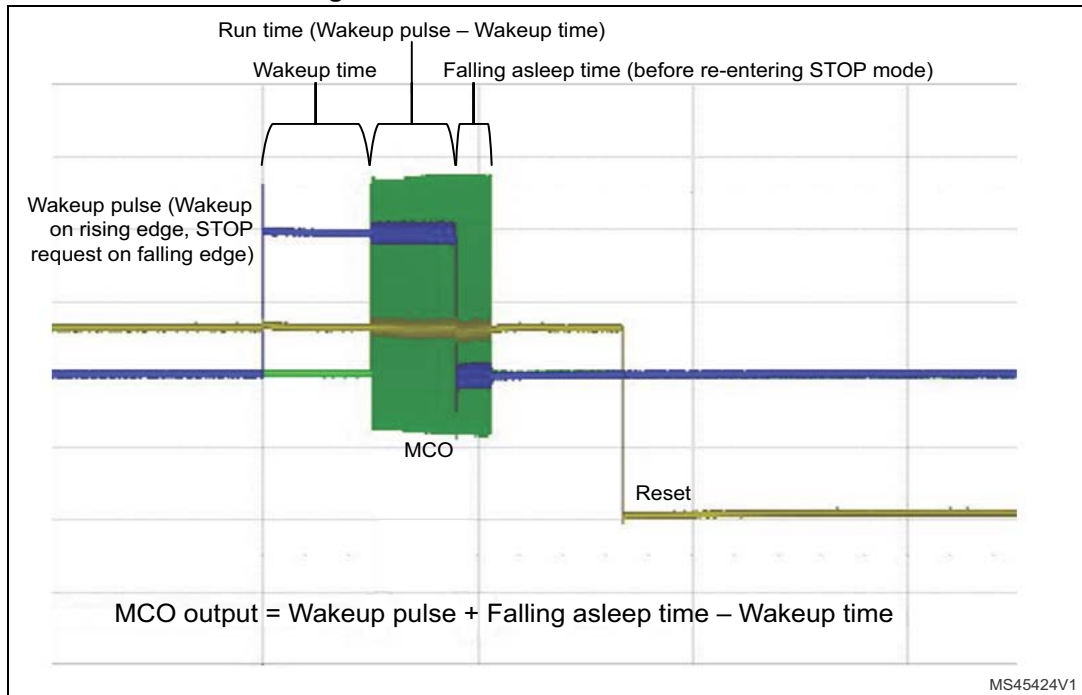
Figure 2. Minimum Run time definition

The minimum Run time defined in [Table 4](#) corresponds to the firmware execution time on the core. Note also that, as shown in [Figure 2](#), the length of the MCO output (green trace) is longer than the firmware execution time.

Ensure that the Run time between two Stop sequences is long enough to avoid the generation of a Brown Out Reset.

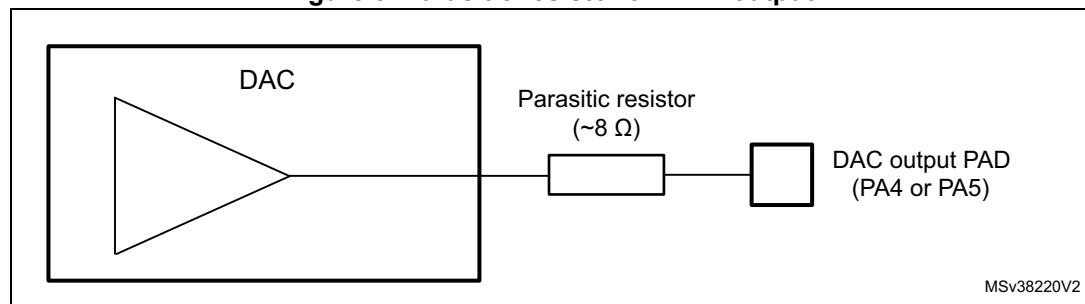
Figure 3. Parasitic resistor on DAC output

2.8.4 DAC characteristics can be degraded depending on the current sunk on DAC output

Resistor value between DAC outputs and I/O (PA4 or PA5) is greater than expected: 8 Ω typical, as shown in [Figure 3](#). As a consequence, the DAC characteristics can be impacted depending on the current sunk on DAC output.

None.

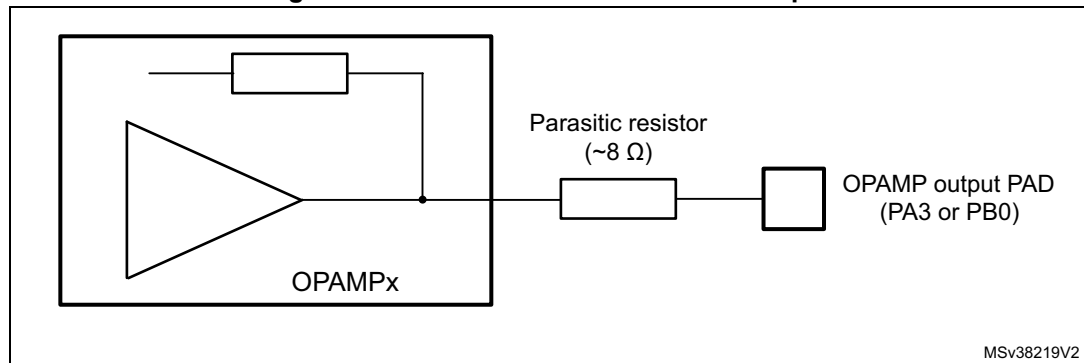
Figure 4. Parasitic resistor on OPAMP output

2.11.1 OPAMP characteristics can be degraded depending on the current sunk on OPAMP output

Resistor value between OPAMP outputs and I/O (PA3 or PB0) is greater than expected: 8 Ω typical, as shown in [Figure 4](#). As a consequence the OPAMP characteristics can be impacted depending on the current sunk on the output.

None.

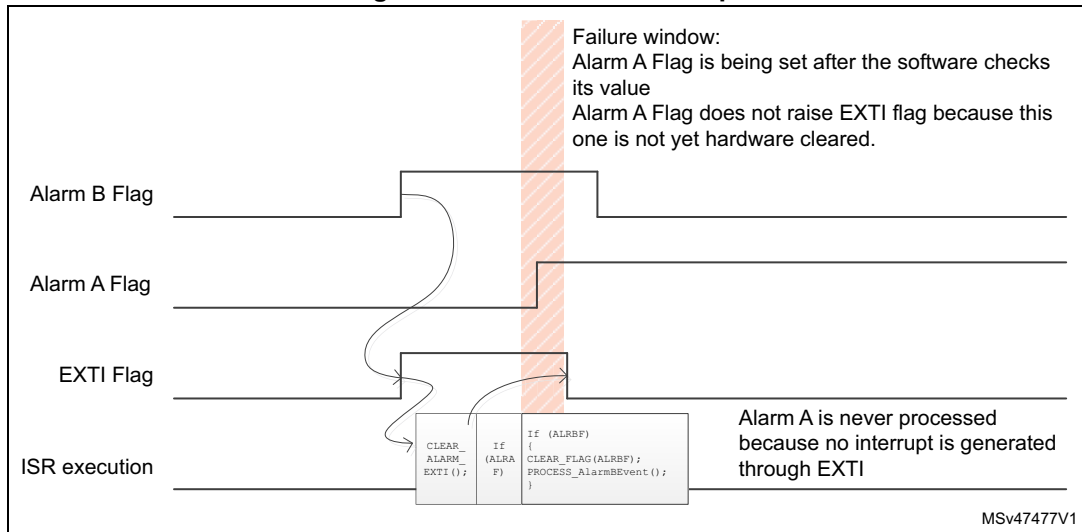
Figure 5. Masked RTC interrupt

The following code example and figure illustrate the failure mechanism: The Alarm A event is lost (fails to generate interrupt) as it occurs in the failure window, that is, after checking the Alarm A event flag but before the effective clear of the EXTI interrupt flag by hardware. The effective clear of the EXTI interrupt flag is delayed with respect to the software instruction to clear it.

In the interrupt service routine, apply three consecutive event flag checks - source one, source two, and source one again, as in the following code example:
