Product Advisory Notice		Date September 30 th , 2022
Product	IX30-00P7 – North America Digi IX30 LTE Cat-7 Product SKU	
Reason for Change	Technical Requirement: Incorrect Firmware image loaded

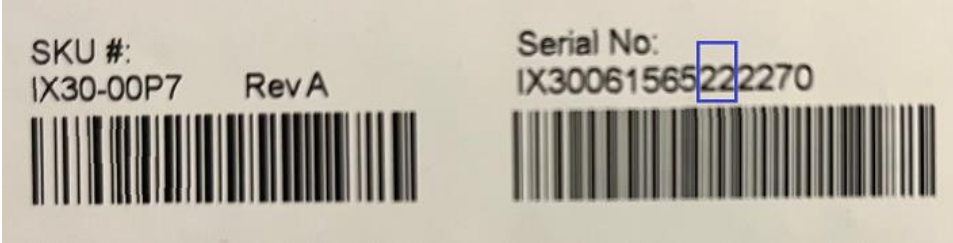
Audience	Distributors carrying inventory and customers with IX30-00P7 routers that fall into the category range defined below.
Reason for Change	<p>IX30-00P7 routers built prior to July 12, 2022, were incorrectly manufactured with PR (Primary Responder) firmware. PR firmware is a more secure firmware, but highly prohibitive in that it does not include shell access. This PCN corrects all IX30-00P7 devices manufactured with PR firmware to enable a firmware upgrade path going forward.</p> <p>A PR device will have a –PR postscript in the Model and Hostname, shown on the Web UI Dashboard or CLI show system command. Alternatively, any IX30-00P7 SKU where the 11th and 12th digits are between 08 and 29 are affected:</p> <div style="text-align: center;">

</div>
Action to Be Taken by Channel Partners	Please contact DigiOrders@digi.com , with a Request to Return the affected Inventory on Hand. Please work with your Channel Sales Manager to place an offsetting purchase order for the corrected/reworked product.

Action to Be Taken by Customers	Please RMA all affected routers. Contact Customer Operations at DigiOrders@digi.com for instructions on how to complete the RMA process.
Relevant Part Numbers	IX30-00P7
Timing of Change	Immediate
Authorization	Kinana Hussain, VP Product – Cellular Solutions, Digi International
