# ***AM572x Sitara™ Processors Silicon Revisions 1.1, 2.0***

## *Errata*

Literature Number: SPRZ429M  
JULY 2014 – REVISED FEBRUARY 2021

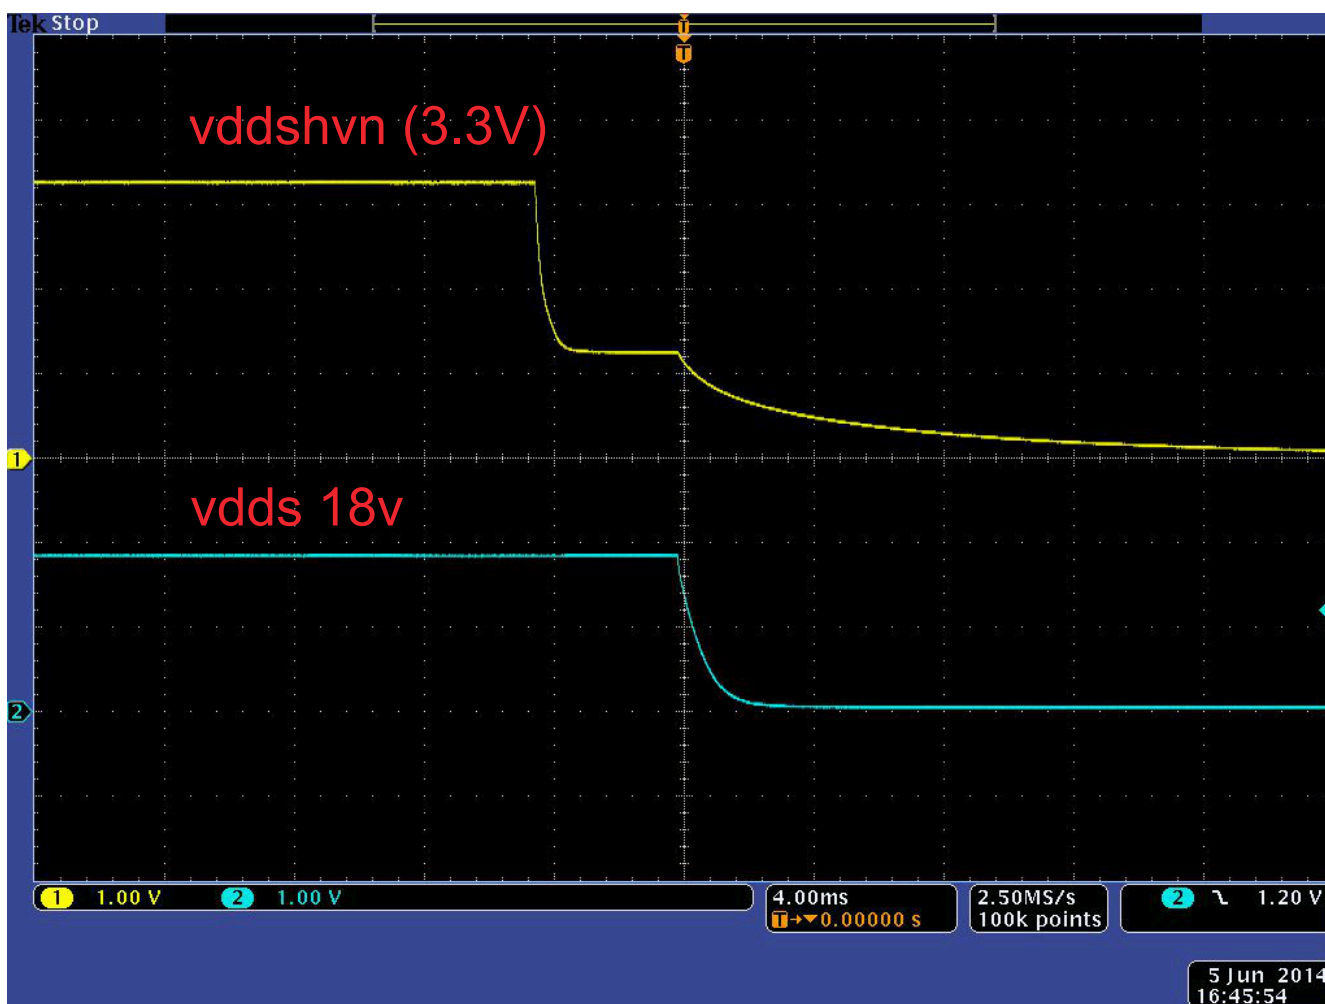
**Figure 4-1. PAB\_RevA**

The Data Manual allows the vddshvn rail (in either 3.3V or 1.8V mode) to power down at the same time or before the vdds18v rail. When the vddshvn rail is powered down before the vdds18v rail, the vddshvn rail stays at Plateau Level (<1.5V) until the vdds18v rail is disabled, as shown in the waveform below.

A subset of the SOC's LVCMOS IOs (refer to DM for details) have a pull-up resistor that is active by default, including during reset and power-down. The SOC's IOs that have internal or external pull-ups will stay at Plateau Level (<1.5V) during the power-down. If other ICs on the board that are interfaced to the SOC's LVCMOS signals use a separate supply then it's possible that the other IC's signals can be pulled to the Plateau Level while its power supply is off.

The root cause of the plateau is related to the LVCMOS IO buffer Dual Voltage detection circuitry. The LVCMOS Dual Voltage IO includes voltage comparator circuitry to determine if the IO is in 3.3V mode or 1.8V mode. During powerdown of vddshvn domains, a current path in the internal bias transistors results in the vddshvn rail being held to an

In general, TI recommends using the same supply source for connected components. E.g., a single LDO should drive vddshvn and the related 3.3V external components.

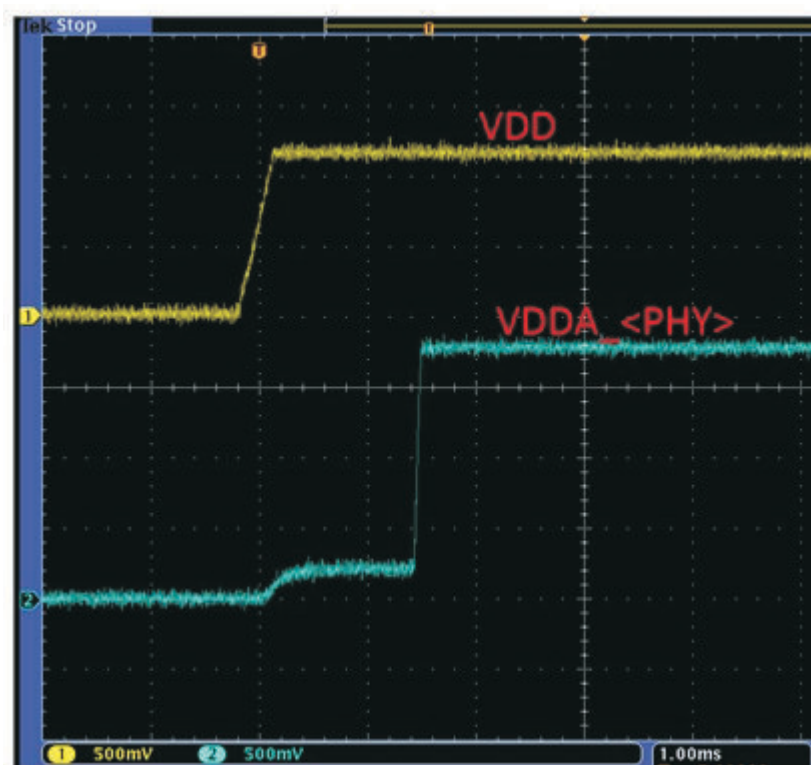
**Figure 4-2. Leakage Voltage**

**DESCRIPTION** A current path exists between VDD and the high speed analog PHY domain (VDDA\_HDMI, VDDA\_PCIE, VDDA\_SATA, VDDA\_USB2/3) during the supply power up and power down sequences.

The device-specific Data Manual requires Core AVS rail (VDD) to power up before the 1.8 V high speed analog PHY domain(s). When this sequence is followed, the high speed analog PHY domain will have a small step-up to a voltage plateau (< 0.5 V) that aligns to the beginning of the VDD ramp-up, and is maintained until the ramp-up of high speed analog PHY rail, as shown in [Figure 4-2](#). Note the leakage value will differ from system to system, but will be less than 500 mV. The leakage voltage in the provided capture is approximately 250 mV.

A similar condition exists during supply power down sequence. The high speed analog PHY domain(s) are required to be powered down prior to Core AVS rail (VDD), and may cause a small plateau to exist until Core AVS rail (VDD) is ramped down.

The root cause of the voltage plateau during power-up/down sequencing is related to the parasitic diodes in logic blocks which have multiple power sources. This leakage path is not a reliability concern for this device.
