STM32L462CE/RE/VE device errata

This document applies to the part numbers of STM32L462CE/RE/VE devices and the device variants as stated in this page. It gives a summary and a description of the device errata, with respect to the device datasheet and reference manual RM0394. Deviation of the real device behavior from the intended device behavior is considered to be a device limitation. Deviation of the description in the reference manual or the datasheet from the intended device behavior is considered to be a documentation erratum. The term “errata” applies both to limitations and documentation errata.

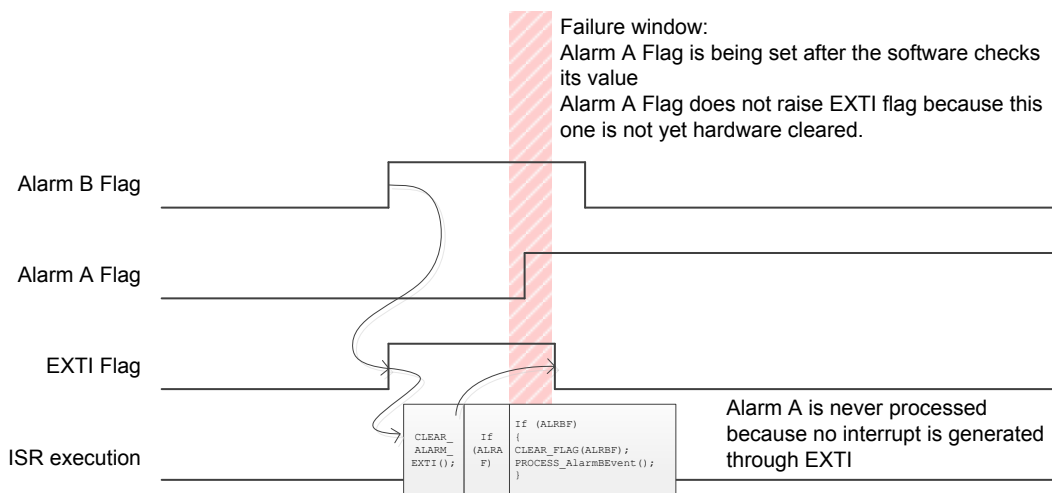
Figure 1. Masked RTC interrupt

The following code example and figure illustrate the failure mechanism: The Alarm A event is lost (fails to generate interrupt) as it occurs in the failure window, that is, after checking the Alarm A event flag but before the effective clear of the EXTI interrupt flag by hardware. The effective clear of the EXTI interrupt flag is delayed with respect to the software instruction to clear it.
