Device **TC23x**
Marking/Step **ES-AB, AB**
Package **see Data Sheet**

10209AERRA

This Errata Sheet describes the deviations from the current user documentation.

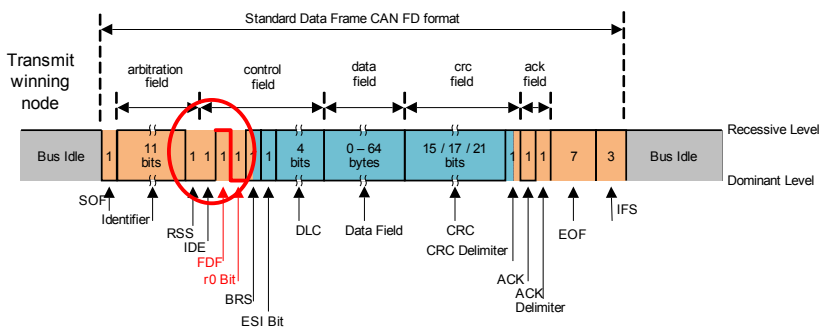
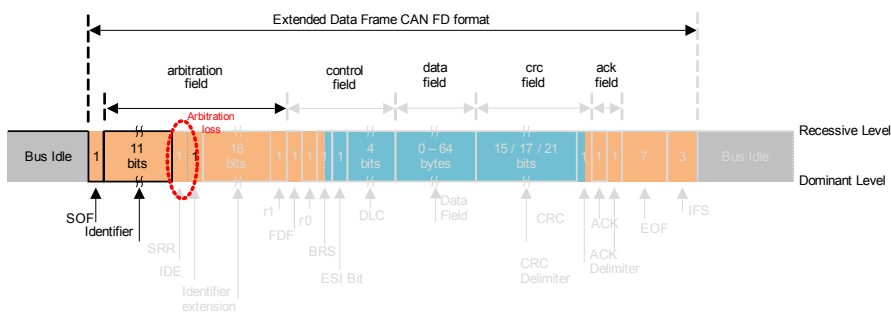
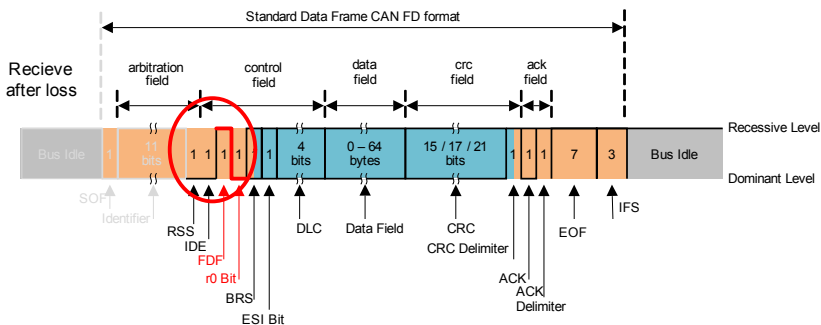
The device is producing more error frames within a network than a device with a hardsync at the FDF bit.

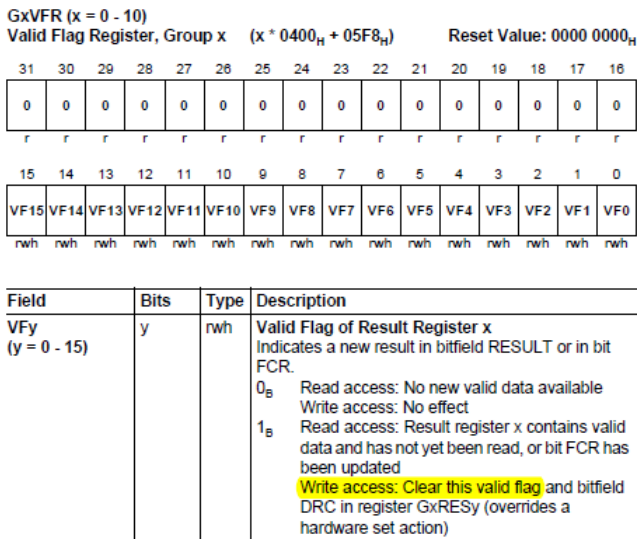
Figure 9 Register GxVFR in the VADC Module of TC2xx Devices

The bits in the GxVFR register have to be written with 1_B to clear a valid flag VF_y indicating a valid result. Assuming VF_y = 1_B, if one of the RMW instructions listed above is used, the write to VF_y would never happen since VF_y is already set to 1_B. This means that the next read of VF_y may lead to incorrect conclusions by software.

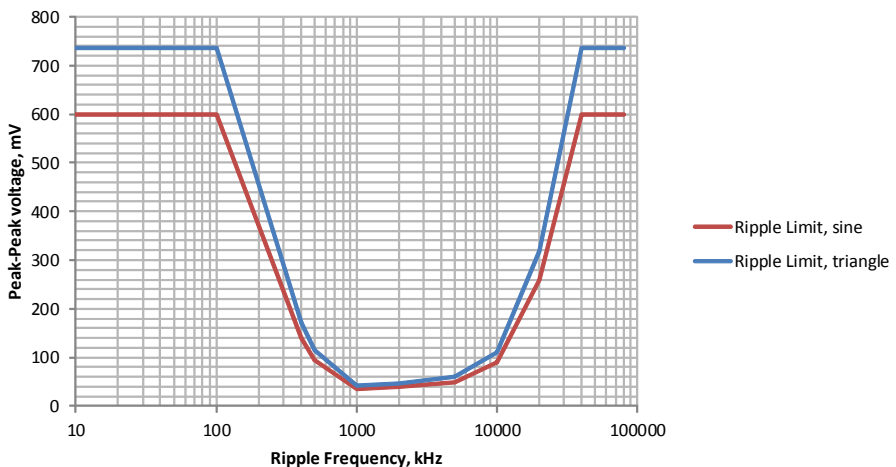
Figure 12 Ripple Voltage vs. Frequency Characteristic

The internal back-up clock is sensitive to specific power supply voltage disturbance/ripple caused by a voltage ripple intrinsic to DC-DC converters. Specific conditions such as insufficient filtering of the ripple may lead to improper behavior of the start-up scheme of the back-up clock, and thus stuck-at state during the start-up of the microcontroller until this condition is removed.

The diagram reflects acceptable ripple level during the cold start of the microcontroller at the respective VDDP3/VEXT/VEVRSB supply of the PMS subsystem, depending on the device and package type, as shown in the following table.

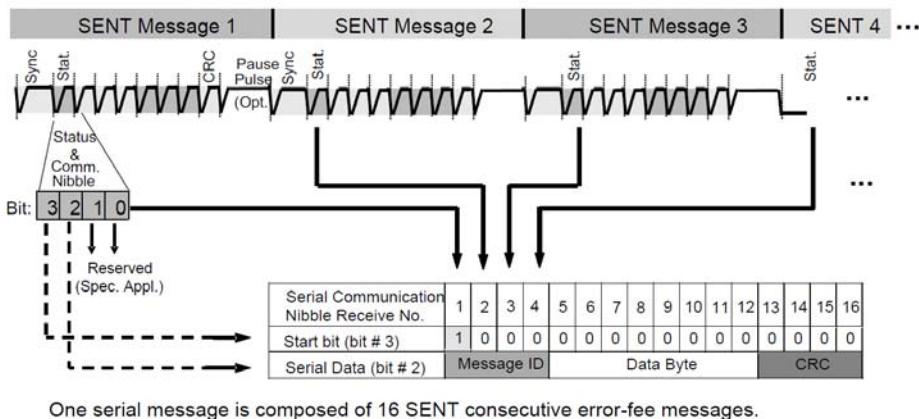
Figure 13 Short Serial Message, Serial Data Encoding over 16 messages

Figure 13 shows a corrected version of this figure.
