Errata
MSP430F5636 Microcontroller

ABSTRACT

This document describes the known exceptions to the functional specifications (advisories).

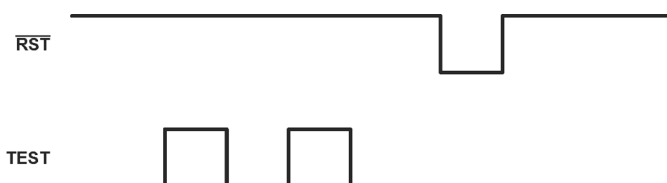
JTAG20	JTAG Module
Category	Software in ROM
Function	BSL does not exit to application code
Description	The methods used to exit the BSL per MSP430 Programming Via the Bootstrap Loader (SLAU319) are invalid.
Workaround	<p>To exit the BSL one of the following methods must be used.</p> <ul style="list-style-type: none"> - A Power cycle <p>or</p> <ul style="list-style-type: none"> - Toggle the TEST pin twice when nRST is high and after 50us pull nRST low.

Note: This toggling of TEST pins is not subject to timing constraints. The appropriate level transitions on TEST pin, followed by a RST pulse after 50us, are sufficient to trigger an exit from BSL mode.
