STM32F078CB/RB/VB device errata

This document applies to STM32F078CB/RB/VB devices and the device variants as stated in this page.

It gives a summary and a description of the device errata, with respect to the device datasheet and reference manual RM0091.

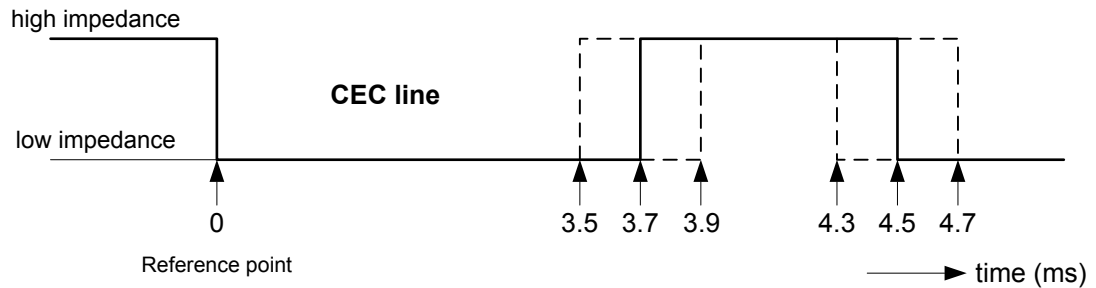
Figure 2. HDMI-CEC start bit format with tolerances

The start bit timing standard tolerances are shown in the following figure. The start bit is initiated by the device by driving the CEC line low (reference point). After 3.7 ms, the device releases the CEC line and starts checking its level. The following conditions must be met for the start bit to be valid:

If one of these conditions is not met, the transmission is aborted and never automatically retried. No error flag is set and the TXSOM (Tx start of message) bit is not cleared.

The only way to detect this error is for the application software to start a timeout when setting the TXSOM bit, restart it upon ARBLST or any RX event (as the transmission can be delayed by interleaved reception), and stop it upon TXBR (proof that the start bit was transmitted successfully) or TXEND event, or upon any TX error (which clears TXSOM). If the timeout expires (because none of those events occurred), the application software must restart the HDMI-CEC peripheral and retransmit the message.
