Errata  
**MSP430F5328 Microcontroller**

**ABSTRACT**

This document describes the known exceptions to the functional specifications (advisories).

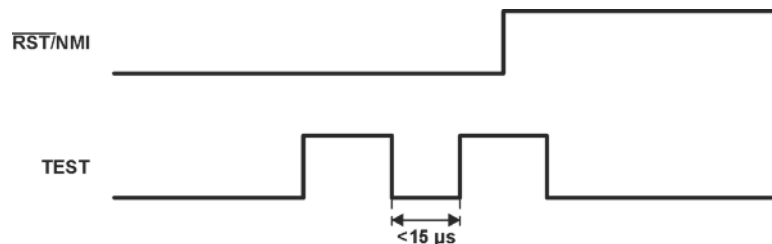
The BSL entry sequence requires that the low phase of the TEST/SBWTCCK pin does not exceed 15us. This timing requirement is faster than most PC serial ports can provide, as shown in the following picture. If this requirement is not met, the entry sequence fails and the SYSBSLIND is not set.

**Workaround** An external hardware solution is recommended to provide the appropriate BSL entry sequence. See [http://processors.wiki.ti.com/index.php/BSL\\_\(MSP430\)](http://processors.wiki.ti.com/index.php/BSL_(MSP430)) for recommendations on available BSL hardware.
