STM32L07xxx/L08xxx device errata

This document applies to the part numbers of STM32L07xxx/L08xxx devices and the device variants as stated in this page.

It gives a summary and a description of the device errata, with respect to the device datasheet and reference manual RM0367/ RM0376/RM0377.

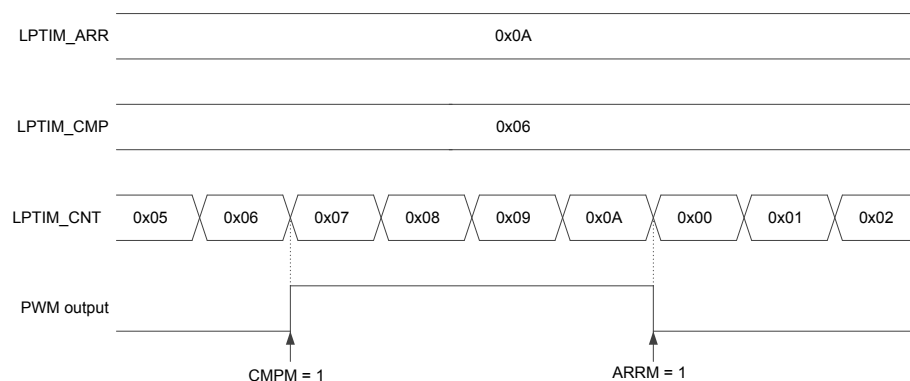
Consequently, it is not possible to generate PWM with a duty cycle of 0% or 100%.

The following waveform gives the example of PWM output mode and the effect of the delay:

Workaround

Set the compare value to the desired value minus 1. For instance in order to generate a compare match when LPTM_CNT = 0x08, set the compare value to 0x07.

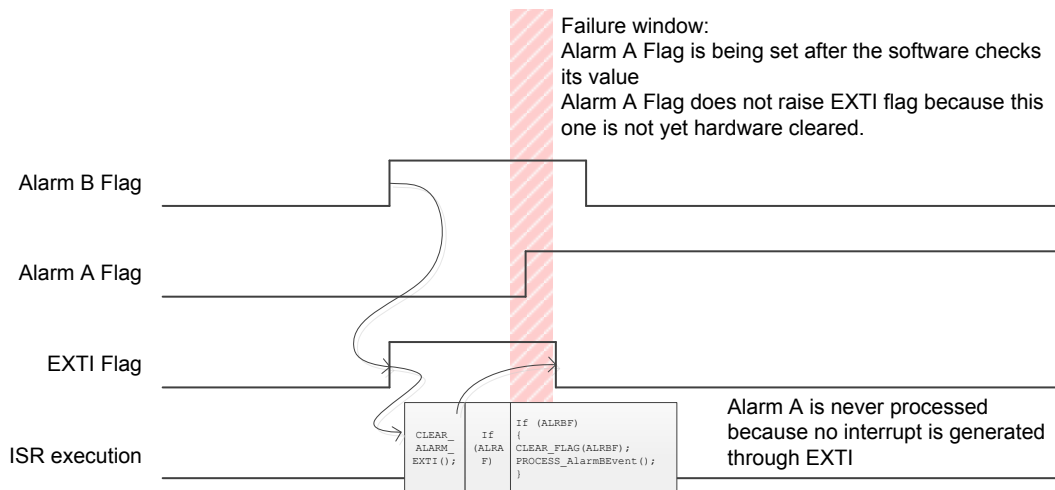
Figure 1. Masked RTC interrupt

The following code example and figure illustrate the failure mechanism: The Alarm A event is lost (fails to generate interrupt) as it occurs in the failure window, that is, after checking the Alarm A event flag but before the effective clear of the EXTI interrupt flag by hardware. The effective clear of the EXTI interrupt flag is delayed with respect to the software instruction to clear it.

Workaround

In the interrupt service routine, apply three consecutive event flag checks - source one, source two, and source one again, as in the following code example:
