Errata

IWR1843 Device Silicon Errata

Silicon Revision 1.0

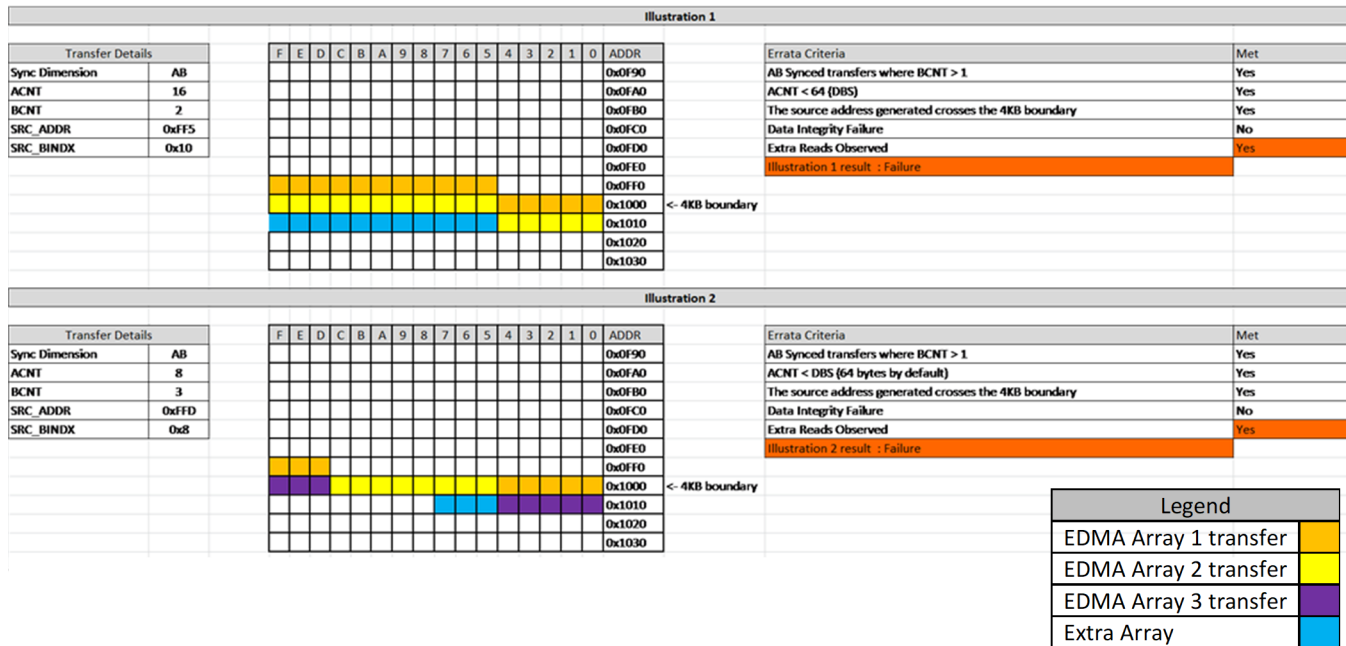
Figure 6-2. Scenario ID #4 – Extra Reads

For each extra read **Scenario ID #4** in for which **Condition [1]** is applicable, there is an extra read from starting address SRC + BCNT * ACNT (=SRCBIDX) of length equal to the distance of the start address to the boundary [that is, length is 0x1000 – X(i)], where i is the index of one and only 4-KB boundary crossing condition. Note: length < ACNT.

Workaround #2 - Scenario ID #3, Scenario ID #4, and Scenario ID #5 (see Table 6-1)– EXTRA READS

For **Scenario ID #3, Scenario ID #4, and Scenario ID #5**– EXTRA READS, another workaround besides avoiding the 4-KB boundary cross conditions, is to ensure that buffers involved in this kind of transfer are positioned so that extra reads stay within the physical memory boundaries. If the extra reads go to Reserved space or space blocked by the Memory Protection Unit (MPU), the TPTC generates a bus error interrupt to the processor.

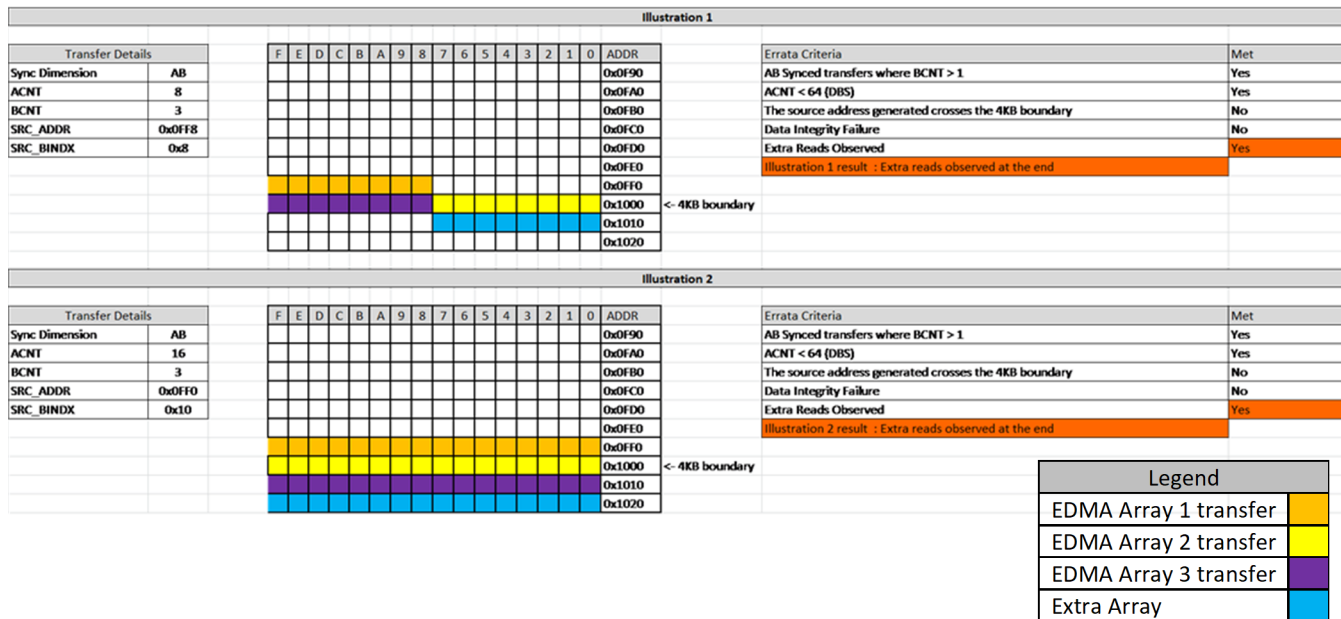
Figure 6-3. Scenario ID #5 – Extra Reads

For the extra read **Scenario ID #5** in for which **Condition [2]** is applicable, there is an extra read from starting address SRC + BCNT * ACNT (=SRCBIDX) of length equal to the distance of the start address and is of length ACNT.

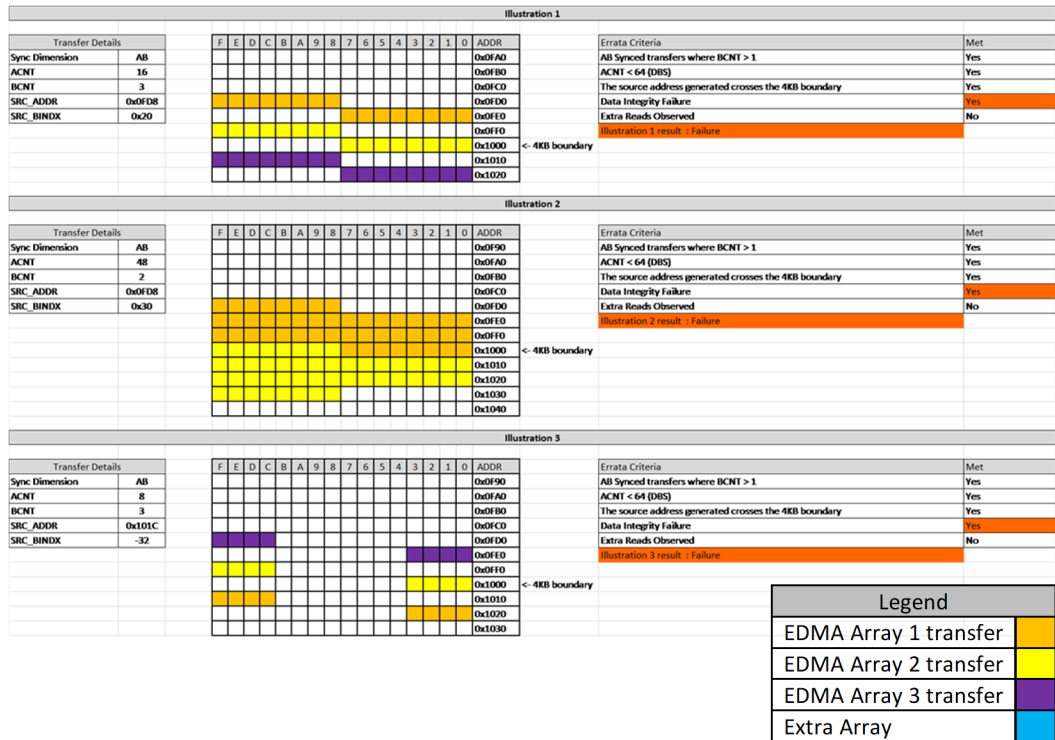
Figure 6-4. Scenario ID #1 – Data Integrity Failure

Certain scenarios could lead to an incorrect read, hang, or data integrity issues in the EDMA TPTC block. [Table 6-1](#) shows the various scenarios and the resulting effects of each scenario.

Workaround(s): **Workaround #1 - ALL SCENARIO IDs (see Table 6-1)**

Prevent one or more of the conditions necessary for the problematic scenarios to happen.
