STM32F412xE and STM32F412xG device errata

Applicability

This document applies to the part numbers of STM32F412xE and STM32F412xG devices and the device variants as stated in this page.

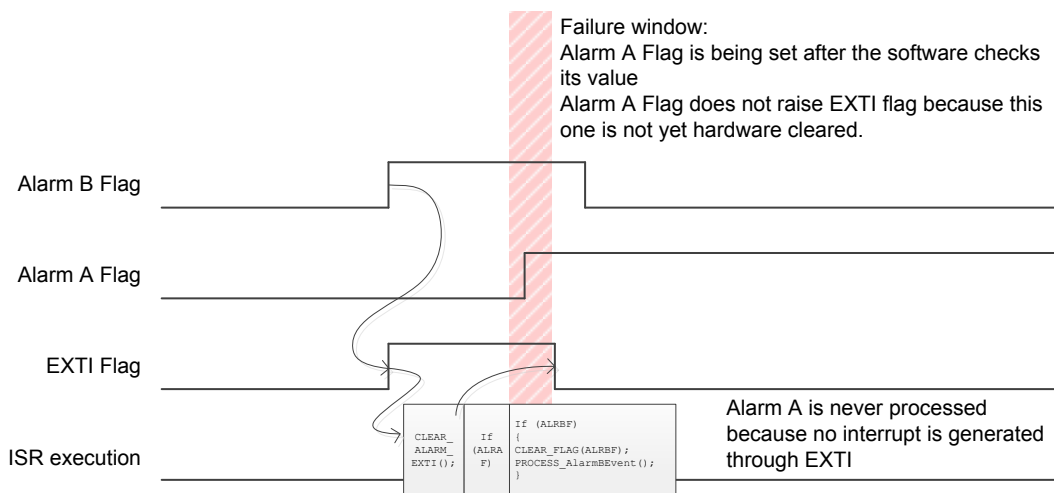
Figure 1. Masked RTC interrupt

The following code example and figure illustrate the failure mechanism: The Alarm A event is lost (fails to generate interrupt) as it occurs in the failure window, that is, after checking the Alarm A event flag but before the effective clear of the EXTI interrupt flag by hardware. The effective clear of the EXTI interrupt flag is delayed with respect to the software instruction to clear it.
