Product Change Notification (PCN)

PCN #: 1A-2019

DATE: 01/29/2019

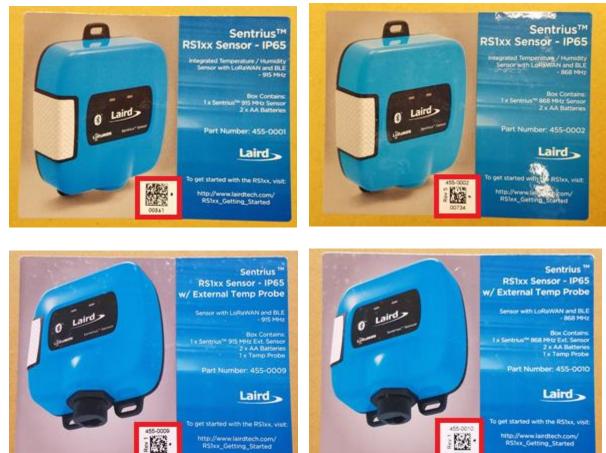
5.1 Top Level Part Number Changes (packaged kits)

- Revision change available as revision number printed by barcode and (or) within the barcode for all kits (455-0001, 455-0002, 455-0009, and 455-0010).
- A black dot will also be seen on all kit labels by the barcode to indicate that the kit has been updated to the latest firmware.

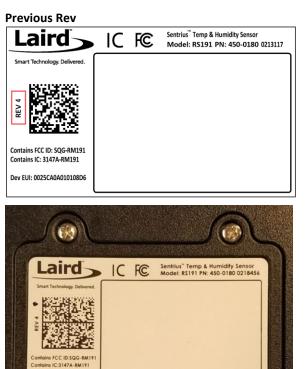
Labelling Changes – 450-0180

A black dot near the barcode will indicator a firmware update to v4.5
