# PRODUCT / PROCESS CHANGE NOTIFICATION

PCN-000791

Date: MAR-08-2022

Semtech's tier 2 supplier has changed their manufacturing process sequence to improve the flex's robustness. The color of the flex plating area has also been changed, but the thickness dimension remains unchanged.

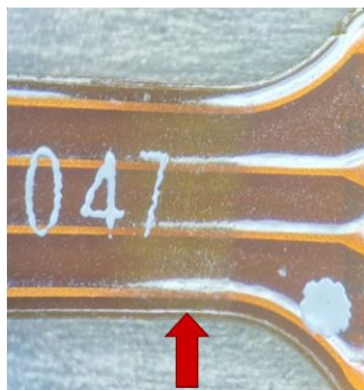
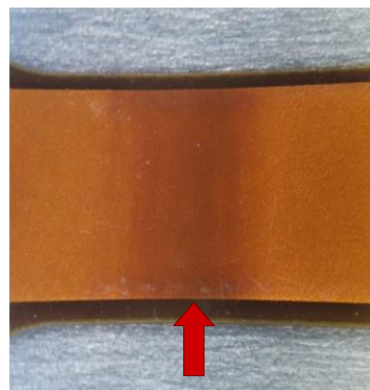
○ **Bending Test**

- Condition: Bending radius 0.4mm, 180 degrees, 25 times
- Samples: 11 units
- Result: The open/short test and visual inspection at the bending area both passed.

Bending area

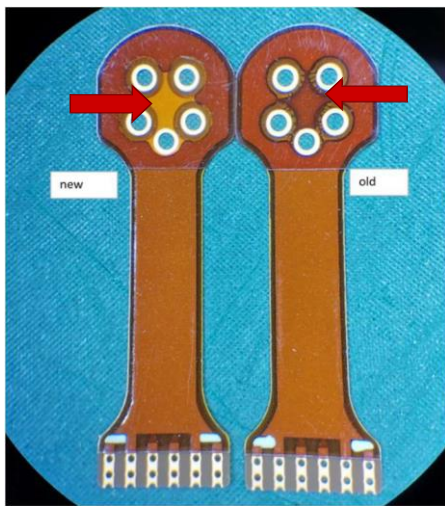
Back side

- A slight color difference can be seen in the center of the back side, left photo. There is no color difference on the front side, as shown in the right photo.
- Visual inspection passed Semtech criteria.

Flex attached to ROSA

New

Old

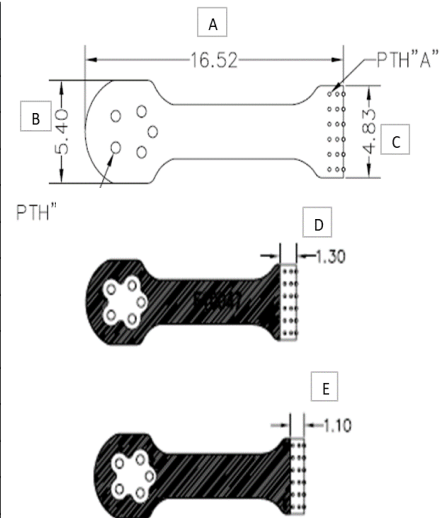
○ **Dimension Measurement**

- Measuring the critical dimensions
- Result: Passed

Tolerance: +/- 0.1mm
