Device **TC23x**
Marking/Step **ES-AC, AC**
Package **see Data Sheet**

10210AERRA

This Errata Sheet describes the deviations from the current user documentation.

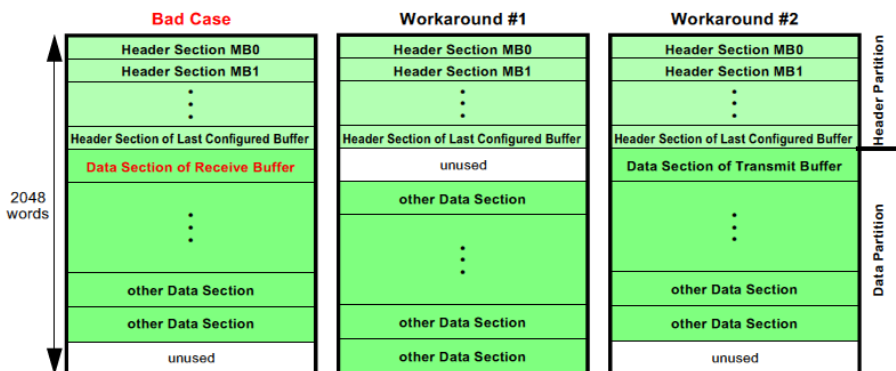
Figure 3 Message RAM Configurations

The erratum is limited to the case when (see [Figure 3](#) “Bad Case”):

2) Ensure that the Data Section directly following the Header Partition is assigned to a transmit buffer.
