ABSTRACT

This document describes the known exceptions to the functional specifications (advisories).

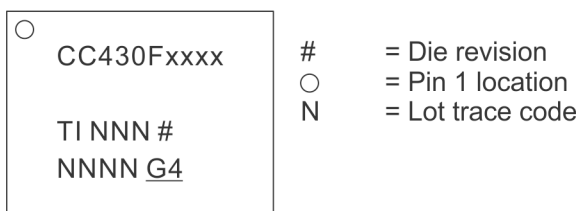
RGC64

QFN (RGC), 64 pin

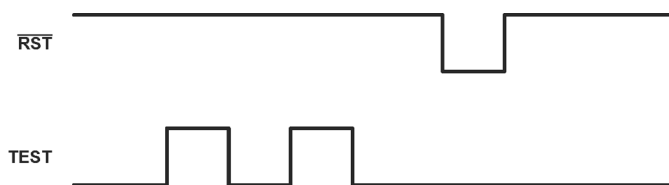
- Toggle the TEST pin twice when nRST is high and after 50us pull nRST low.

Note: This toggling of TEST pins is not subject to timing constraints. The appropriate level transitions on TEST pin, followed by a RST pulse after 50us, are sufficient to trigger an exit from BSL mode.
