## Discontinuation Notice for EVQ-9P701K Light Touch Switch

PDN.PG26.04.23.2015

04/23/15

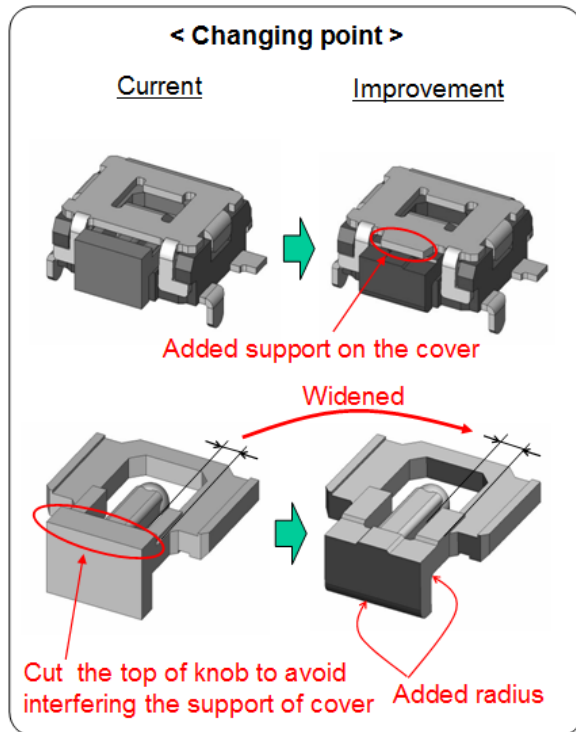
<Test method>

After the P.W.B is horizontally fixed as shown in figure 1, pressure is applied to the switch gradually by push-pull gauge and the force was measured when the push plate broke down.

<Test result>

(Unit : N)

Improvement	Current
1	8.6	5.1
2	9.2	5.3
3	9.6	4.7
4	9.8	4.9
5	9.4	4.5
6	9.1	4.6
7	8.8	4.8
8	8.7	5.0
9	8.9	4.6
10	9.1	4.6
Ave	9.12	4.81
max	9.8	5.3
min	8.6	4.5
$\sigma$	0.39	0.26

Push plate strength of improvement : 8.6 – 9.8 N
